CASE HISTORY

ECP HELICAL TORQUE ANCHORS™

Tieback Anchors Repair Tilting Foundation Walls Denver, Colorado

Project Summary

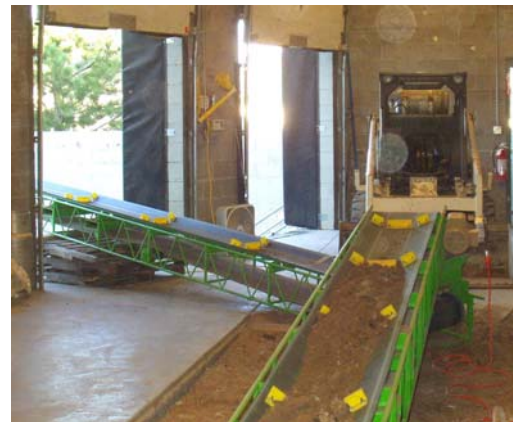
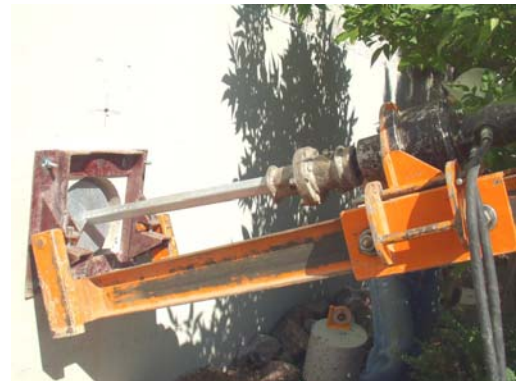
From the top: Soil removal was accomplished by conveyor as workers dug behind the stem walls. A helical tieback is installed at the specified angle.
