### Emergency Battery Packs Cause Slab to Settle

| Project Summary | |
|---|---|
| Project: | Supplemental Support for Emergency Batteries<br>Seattle, Washington |

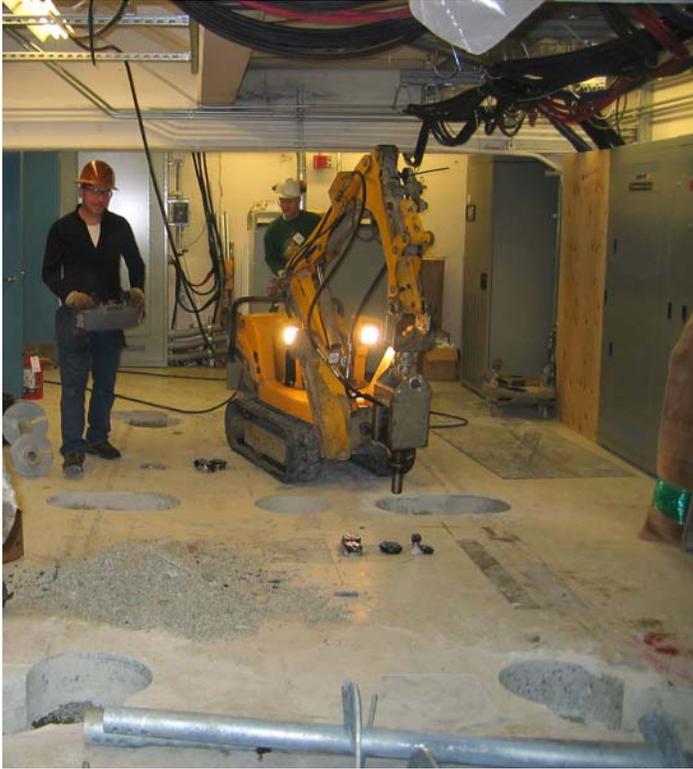
Photographs: At the top is a view showing the tight area of work in the emergency battery room. Access holes for the helical piles have been drilled in the floor. Unfortunately, obstructions required relocating several placements. At left is a view of the Brokk 90 Mobile Driller. The machine was fitted with an Eskridge 4K5 hydraulic gear motor that provided up to 4,500 foot-pounds of torque for the rotary installation of the piles.

After investigating the advantages and disadvantages of several underpinning systems, Pile King proposed to the owner to install ECP Torque Anchors™ as the best solution to provide supplemental support to the affected area. However, this solution was not without challenges. The battery room was located on the lower level of the building; the room had low overhead clearance and was located some 300 feet from the nearest entrance. In addition, the work had to be completed rapidly because once the back-up power system was

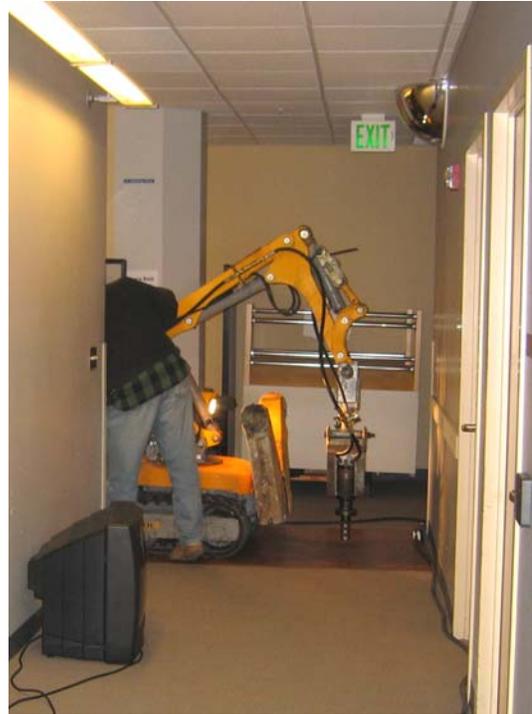
Photographs: Above right shows the maneuverability of the Brokk machine. Here the workers are guiding it through the office space on its way to the emergency battery room on the lower level. Below are two views of the job site. The emergency battery packs occupy the area where the floor has been drilled. ECP Helical Torque Anchors™ were installed under each battery array, which provided additional working load support of 15,000 pounds per pile placement.
